Hughes Warehouse Adaptive Reuse

Project Overview

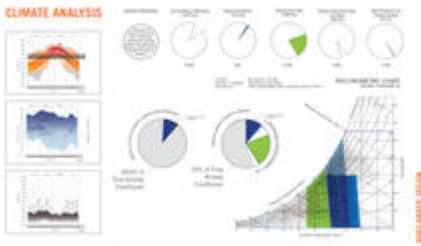
Bioclimatic Design

Honoring the history of the building, the design team left the existing double wythe brick walls mostly intact but improved thermal insulation through the addition of R20 rigid roof insulation. The roof was upgraded to a reflective TPO cool roof to mitigate heat gain. Though the original steel frames surrounding the clerestory windows would only accept 1/4-inch laminated safety glass, the new punched windows and curtain wall feature one-inch-thick Solar Band 70 XL coated high-performance glass. Steel window box shades surround the windows along the east and west facades. To mitigate solar gain, the new shades are extruded about a foot on the east side of the building, and about two feet on the west. The clerestories and courtyard curtain wall are equipped with translucent, automated shades that control glare without obscuring views and also abide by the astronomical clock. These combined shading strategies have reduced the amount of time that requires active conditioning by 18.5% per year. The courtyard curtain wall illuminates interiors but is shaded by the preexisting south façade, preventing direct glare. A 65 kW photovoltaic rooftop array generates approximately 46% of the energy needed for building operations.

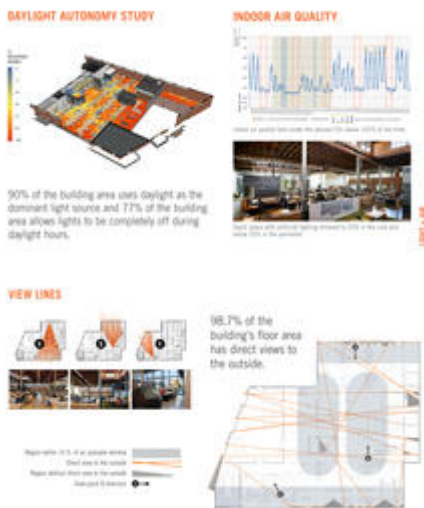
Light & Air

Other than clerestory windows and several loading dock entries, the building was entirely encased in a double wythe brick wall. While the clerestories provided daylight to the interior, they provided only views to the outside of the sky and did not facilitate the transition from streetscape to interior. By adding punched windows along the east and west facades and a glass curtain wall to the newly inserted courtyard, views to the outside are available in 98.7% of the floor area. Additionally, the clerestories, which had been painted over, were made

operable once again, providing natural ventilation to building occupants when desired. 60% of the office floor area is within 15 feet of an operable window, accessible to 48 of 77 full-time employees. CO2 meters monitor indoor air quality, which fall below the threshold for indoor CO2 levels.

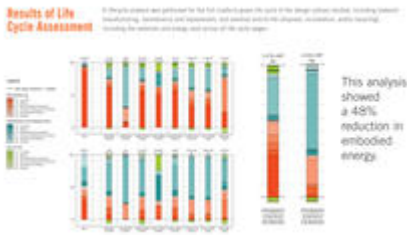
Materials & Construction

With the attitude that the most sustainable building is the one that is already built, existing elements were cleaned up but remain largely intact. The structure was left exposed to minimize material use, and materials were repurposed wherever possible. Furniture from the previous office was remilled and reassembled to create workstations that supported the open plan. Reclaimed teak was used for doors on meeting pods. Selected in part for their durability, glass and steel components—such as punched windows and a window wall overlooking the courtyard—were integrated into the existing longleaf pine and brick structure, providing natural light and ventilation to interior spaces. Timber salvaged from the roof joists was repurposed as stair treads and for board-formed concrete poured onsite. Sections of otherwise unusable concrete floor became pavers in the alley. Recycling, catering, kitchen, and green cleaning policies have been implemented, as well as a composting program for use in the alley garden.

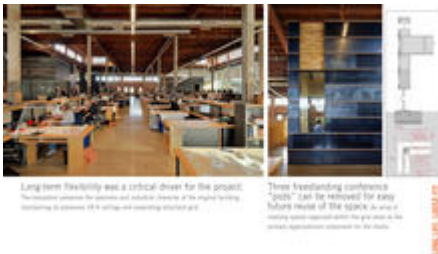
Long Life, Loose Fit

Because the tenant spaces are occupied under leasing agreements, long-term flexibility was a primary focus. The renovation preserves the building's original open plan structural grid. An array of meeting spaces organized within the grid serve as the primary organizational component for the studio. The enclosed meeting spaces consist of a bank of conference rooms at the rear, built of DIRT modular wall systems, which can be removed and reconfigured over time. Three freestanding conference "pods" function as meeting spaces, and can also be removed without altering the building's structure. In addition, none of the office furniture is built in except for kitchen cabinets. These strategies allow the space to easily be reused and reconfigured by future tenants.

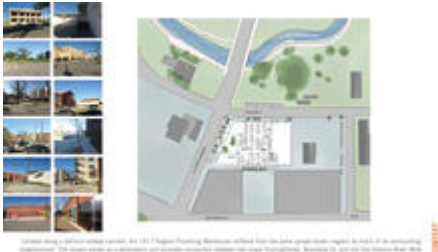
Collage showing various building exteriors for 2013 Project Planning. Maximum number for the same project under the scope of the commissioning agreement. The main image is a site plan showing the location of the building on the site.
