## Arizona State University Student Health Services

### Project Overview

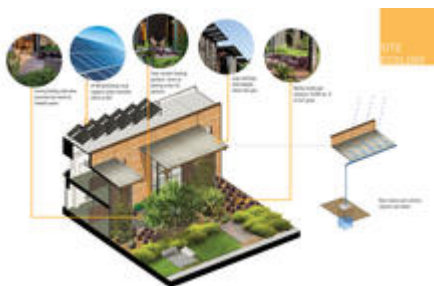
*Site Ecology Strategies Diagram - Photo Credit: Lake|Flato Architects*

The built facility represents a significant departure from the university's original approach to the building's phasing and expansion. At the project's inception, the university proposed maintaining the entire existing facility and adding a new two-story, 9,000-square-foot addition to the north end of the site on existing open green space. Through a thorough programming and cost analysis process, the design team recommended renovating the 1950s 14,500-square-foot two-story wing, deconstructing the oldest and least efficient single-story part of the facility, and constructing a new 20,000-square-foot two-story addition in its place. The solution significantly increased the facility's efficiency, reduced program by 12% and the facility's footprint by 20% while preserving 5,000 square feet of open green space. Additionally, the revised concept enabled the renovated facility's main entrance to be located on the historic Palm Walk, the campus's main pedestrian spine, resulting in a more accessible facility and vibrant pedestrian campus. The revised concept also facilitated the removal of approximately 10,000 square feet of turf grass, replaced by native landscaping irrigated by rainwater harvested from the facility's roofs and stored in sub-grade cisterns.

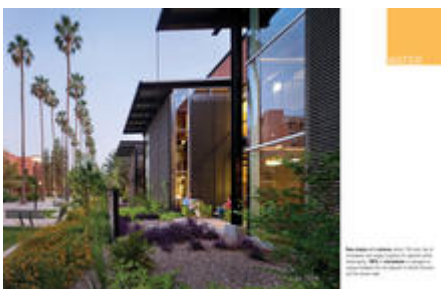
*Rain chains with cisterns collect 138 cubic feet of stormwater and supply irrigation for adjacent native landscaping. All of stormwater is managed on campus between the site adjacent to Health Services and the alumni lawn. - Photo Credit: Bill Timmerman*

Finally, the project supports ASU's campus-wide goal of managing all stormwater on campus. The existing alumni lawn was leveraged to aid in stormwater management instead of adding new infrastructure to the project. All stormwater is managed on site or on the alumni lawn adjacent to the Health Services Building. Rain chains attached to subsurface cisterns account for 138 cubic feet of rainwater harvested from the lower roofs, which is used to irrigate the project's native landscaping. The cisterns utilize pieces of recycled concrete slab from the existing building.

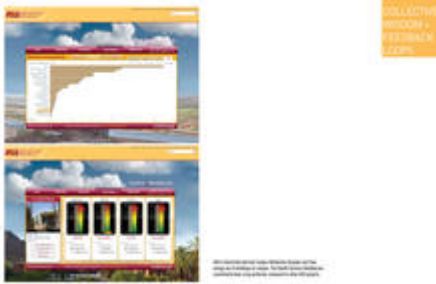
*ASU's interactive web tool Campus Metabolism displays real-time energy use of buildings on campus. The Student Health Services Building has consistently been a top performer compared to other projects on campus. - Photo Credit: cm.asu.edu*

ASU utilizes an interactive website called Campus Metabolism ([cm.asu.edu](http://cm.asu.edu)) that enables the public to view the current resource use of numerous buildings on campus, including the Health Services Building. ASU is currently installing sensors on campus buildings and tracking energy, including chilled water, electricity, and hot water/steam. In the near future, Campus Metabolism plans to display water and waste, as well as other important resource information. The Health Services Building's energy performance can be viewed in real-time and compared to other projects on campus on this website. Per square foot, the Health Services Building is consistently one of the top performers on campus.

Historical data for performance can also be viewed on this website, which proved to be a valuable diagnostic tool for this project. The team noticed a spike in heating energy last July and was able to troubleshoot and find a steam leak in the building, an issue that may not have been identified without this tool.

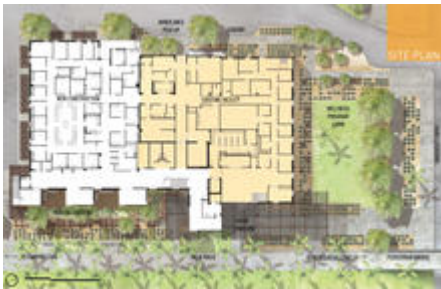
*ASU Student Health Services  
Building Site Plan - Photo  
Credit: Lake|Flato Architects*
