Mercy Corps

Project Overview

THA Architecture

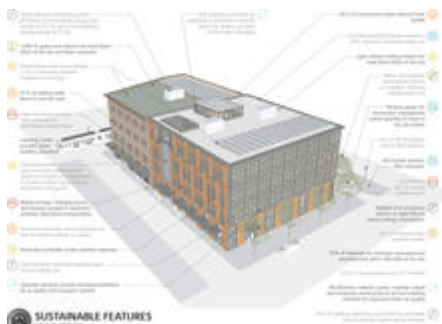
*Mercy Corps Sustainable
Features - Photo Credit: THA
Architecture*

For the new addition, an exterior terra-cotta rainscreen system (its first use in Oregon) has a textile-like pattern, referencing cultural artifacts collected by Mercy Corps and complementing the scale and proportion of the adjacent facades. Its transparency and materiality provide a symbolic link between the organization and the community.

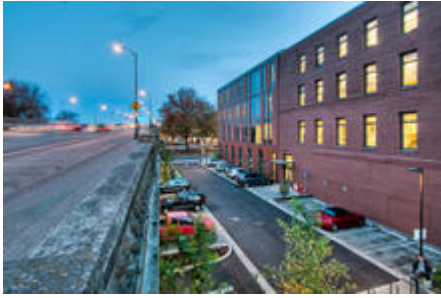
The small parking lot to the north is paved with pervious pavement to encourage direct ground infiltration during rainfall - Photo Credit: Jeff Amram

The building redeveloped a major brownfield and infill site in the city, densifying and reinforcing the urban fabric while protecting adjacent environments, which include a significant urban park and weekend public market. Full cut off downlights for site lighting reduce light pollution, and the small parking lot to the north is paved with pervious pavement to encourage direct ground infiltration during rainfall.

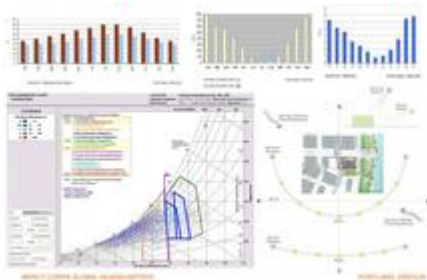
*Bioclimatic information -
Photo Credit: THA Architecture*

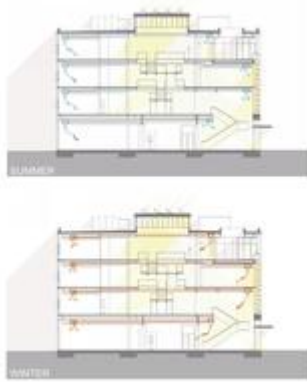
MERCY CORPS GLOBAL HEADQUARTERS PORTLAND, OREGON

*Mechanical Sections - Photo
Credit: THA Architecture*

The mechanical system was designed to be simple, decreasing operation and maintenance costs while operating efficiently and in conjunction with other strategies to reduce overall energy use. The grand staircase at the heart of the building acts as a ventilation stack, drawing air in and up through a monitor-controlled clerestory. Combined with operable windows, this strategy reduces any need to cool the building by drawing cool summer breezes from the north side to the south side of the building and stair stack. During the winter months, however, the north side of the building benefits from passive solar heat gain.

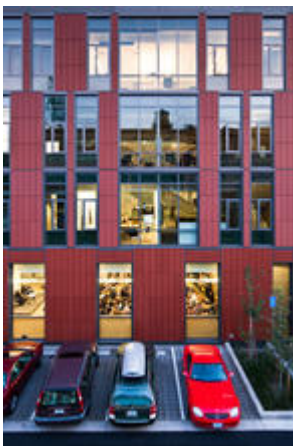
On-site paving is pervious to encourage direct ground infiltration - Photo Credit: Jeff Amram

Potable water use was reduced by 40% by installing water-saving plumbing fixtures, such as low-flow faucets and dual-flush toilets. Landscape plants are xeriscaped to eliminate the need for irrigation water, resulting in a more than 50% reduction of potable water consumption for irrigation. On-site paving is pervious to encourage direct ground infiltration during rainfall.

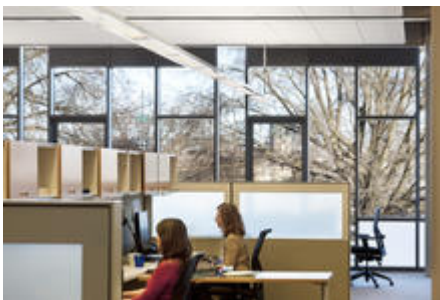
The furniture used a new “benching” system comprised on a spine with movable tables and files - Photo Credit: Lara Swimmer

On the interior, the large number of open office areas allows for flexibility for future changes. In addition, the furniture used a new “benching” system comprised of a spine with movable tables and files. This allows easy expansion and contraction of work stations or quick rearranging of teams for emergency response. Finally, the manufacturer, Herman Miller, has committed to sustainable practices in its factory and materials; they not only accept systems at the end of their life but also recycle most of the components.
