Mercy Corps

Project Overview

Their new headquarters is comprised of the restoration of a 42,000 sf neglected historical landmark in a challenging urban district and an addition of similar size. An egalitarian layout and environmental features actualize Mercy Corps' mission to foster sustainable economic development through collaboration and self-empowerment while also helping to revitalize the neighborhood.

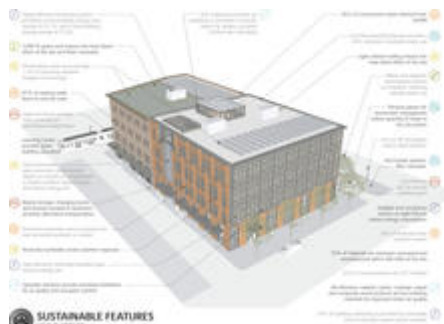
*Mercy Corps Sustainable
Features - Photo Credit: THA
Architecture*

For the new addition, an exterior terra-cotta rainscreen system (its first use in Oregon) has a textile-like pattern, referencing cultural artifacts collected by Mercy Corps and complementing the scale and proportion of the adjacent facades. Its transparency and materiality provide a symbolic link between the organization and the community.

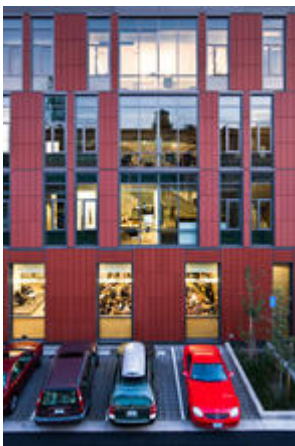
On-site paving is pervious to encourage direct ground infiltration - Photo Credit: Jeff Amram

Potable water use was reduced by 40% by installing water-saving plumbing fixtures, such as low-flow faucets and dual-flush toilets. Landscape plants are xeriscaped to eliminate the need for irrigation water, resulting in a more than 50% reduction of potable water consumption for irrigation. On-site paving is pervious to encourage direct ground infiltration during rainfall.
